SUDBURY DAM

MA 00741

PHASE I INSPECTION REPORT
NATIONAL DAM INSPECTION PROGRAM

SEPTEMBER 1978

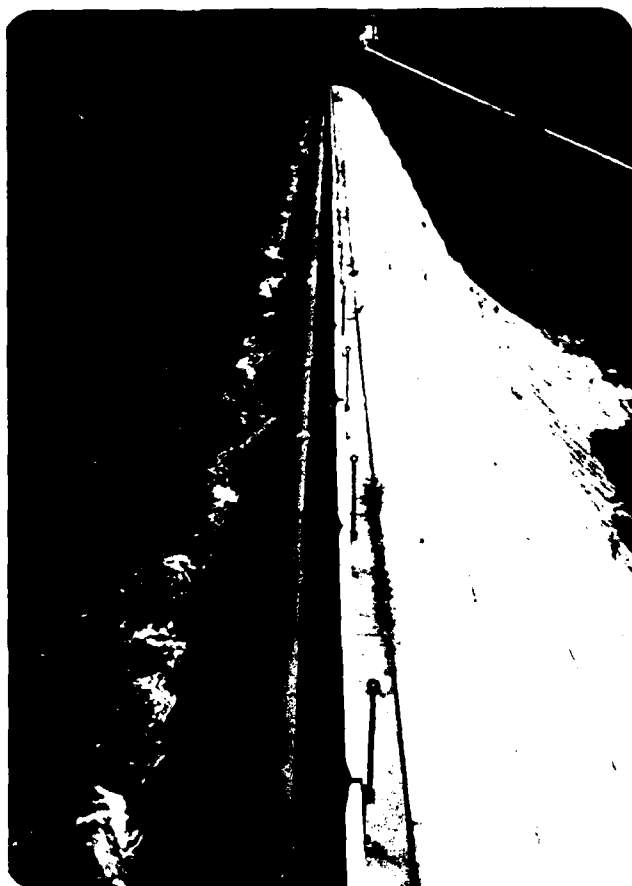
7. Crest of Spillway
Weir Showing
Flashboards

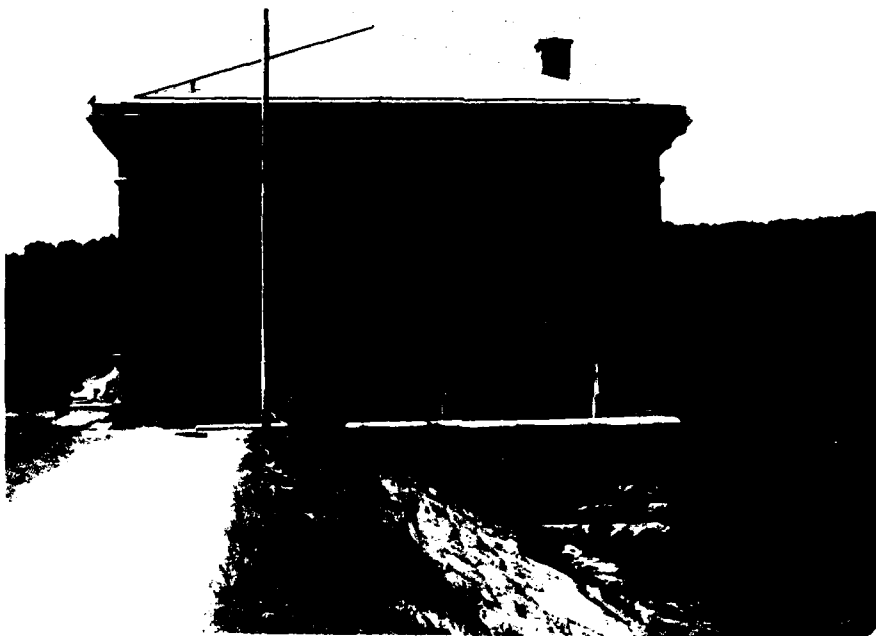
The control house exterior masonry is in good condition, Photo No. 12. The upper joints in the masonry indicate the loss of some mortar. The windows and doors are in poor condition. The interior main floor of the structure has been modified a number of times. Grating and steel plates cover abandoned openings in the slab. One area of the floor adjacent to a covered opening shows intentional or unintentional distortion. The shafts below the main floor were not available for observation during the inspection. However, the one shaft viewed from the top indicated that the shaft was brick-lined and in good condition (in the upper region).

12. Gate House

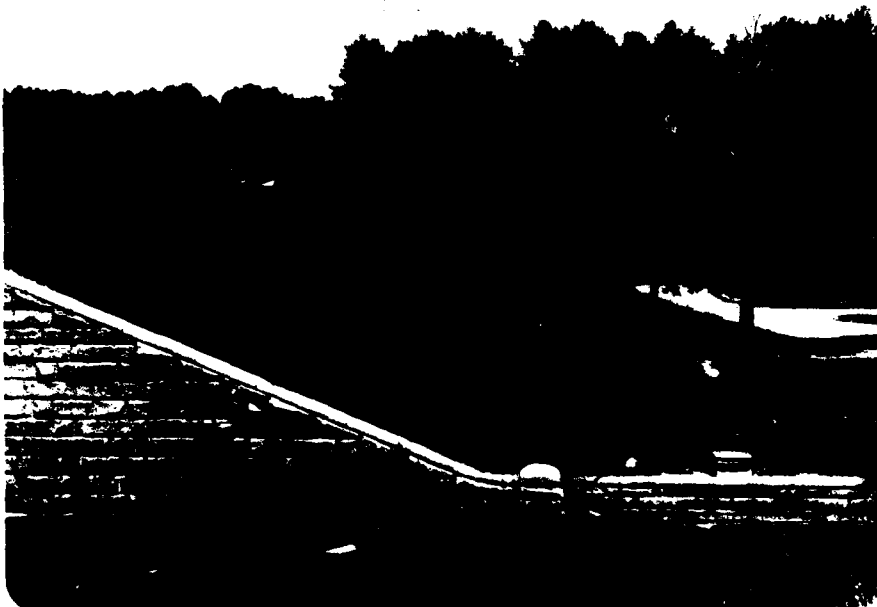
The left spillway training wall contains three weep holes at the lower end, with the two weepholes closest to the weir discharging water. More water was observed flowing through the joints in the lower portion of the wall than through the weep holes. The seepage, efflorescence and moss growth are primarily in the lower regions of the wall, Photos No. 17 and 18.

17. Downstream End of Left Training Wall

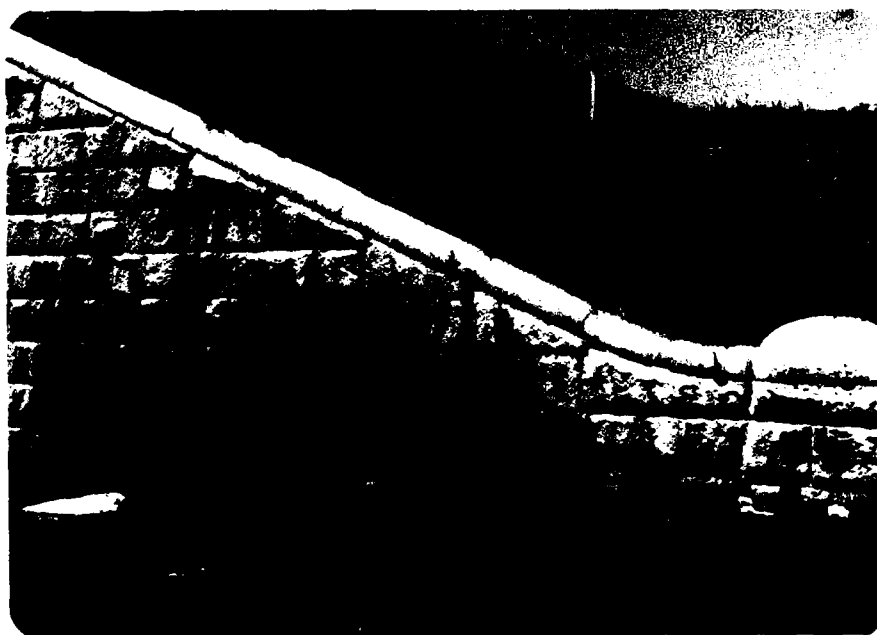
The concrete core wall which separates the two sections of the embankment is founded on bedrock, according to the record drawings. While the condition of the wall is unknown, it is probable that the wall along with the "boulder clay puddle" upstream will effectively control seepage through the embankment. It is probable, therefore, that water in the wet areas which occur downstream of the toe, especially at the left side, originates from bedrock which occurs at shallow depths below existing ground. Some seepage from the rock into the "sand and gravel" of the downstream portion of the embankment is also occurring. The line of seepage appears to be somewhat above the toe. Further evidence of seepage and high water levels left of the spillway is given by seepage through the downstream end of the left training wall, Photo No. 18.

18. Seepage Through Downstream End of Left Training Wall

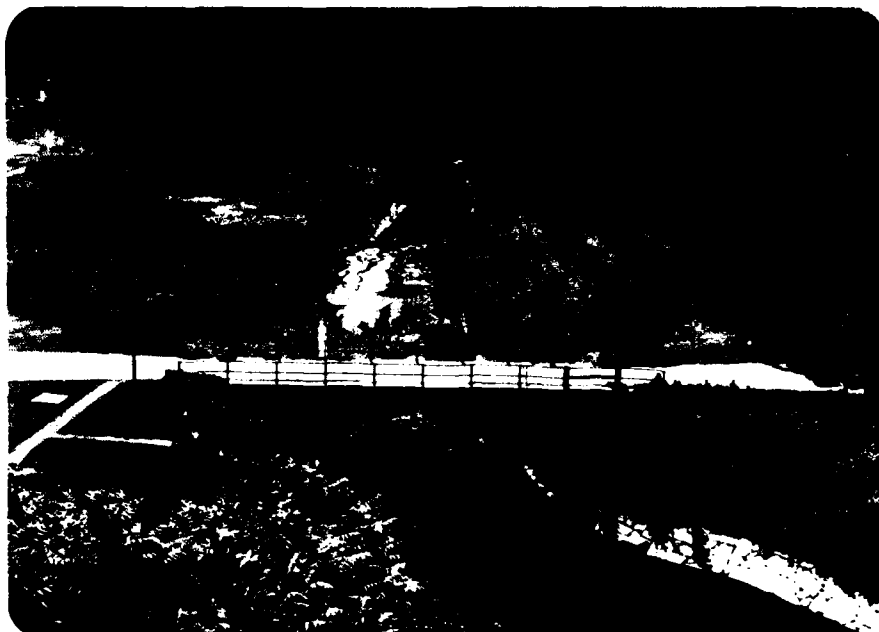
sonry wall on the right, extend a short distance downstream of the roadway bridge, Photos No. 21 and 22. Conditions further downstream are shown in Photo No. 21.

21. Channel and Bridge Downstream of Dam
